## **“Antenna Ratio (‘Antenna Rule’) Violation Causing ‘Super I/O’ Device Failure Affecting Both Yield and Reliability Stress Results”**

A National Semiconductor Quality White Paper

**Ted Hasegawa (NSSC), James Caldwell (NSME), Reuven Stern (NSTA),  
and Jalal Abu Teir (NSTA)**

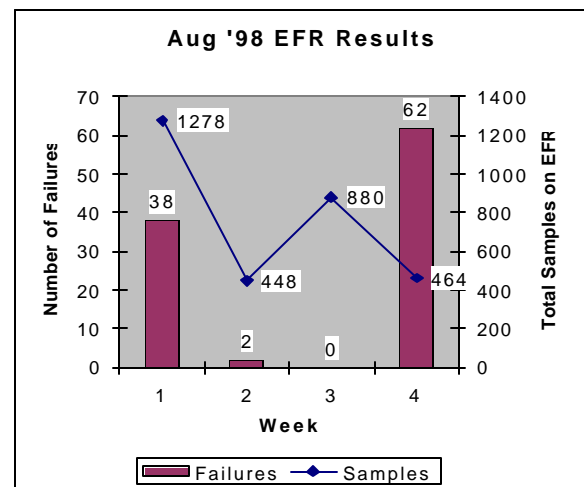
Figure 1: Variable EFR Performance in August 1998

During August of 1998, the variability of the results continued as more lots were monitored via the EFR sampling. During any given week, the number of failing lots never numbered more than two, i.e., failures were generated from distinct lots and not across all lots.

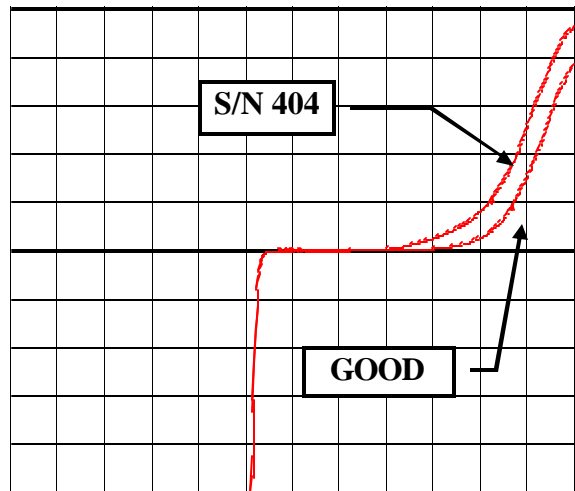
Figure 3: Device failed FDC104 and

Iccsb = 600 $\mu$ -mA

Horizontal = 0.5-volts / division

Vertical = 100- $\mu$ A / division

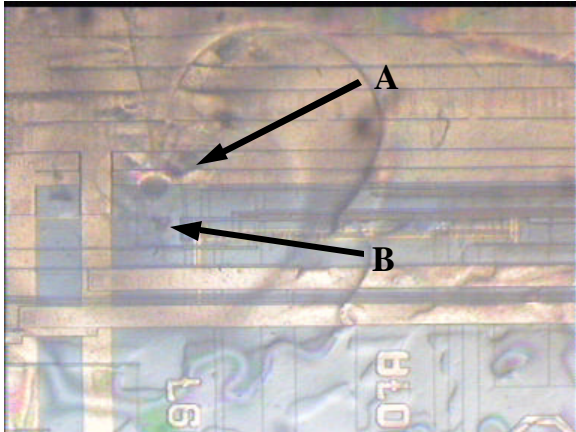
For many cases, physical damage, i.e., fused aluminum, was visible in circuitry near the failing pin. In other cases, liquid crystal techniques were required to aid the fault isolation (see Figure 4). Emission microscopy analysis was also successful in some instances, but consistent results were not obtained, i.e., some failures did not have an emission

Figure 4: Liquid crystal analysis 'hot spot' at Site A

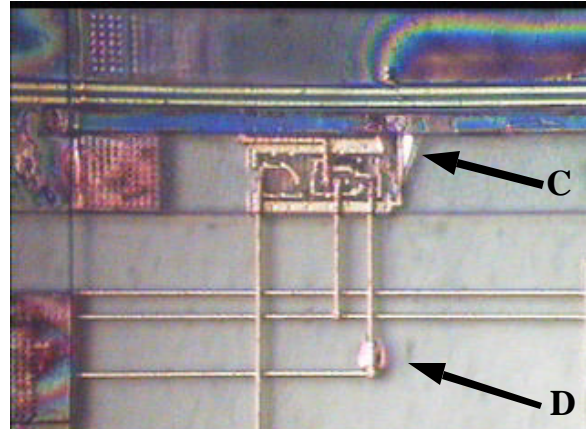
Figure 6: Optical view after top metal was removed  
Note: Fused aluminum exists at two sites and Site D is the same location as Site B in Figure 5

Passivation and the top metal layers were removed to facilitate the inspection in the Schmitt Trigger circuit area for any damage to the portion of the circuitry underneath the wide metal busses. Damage in the form of fused aluminum was observed on failing devices. Figures 6, 7, and 8 are views on different devices, but in the same area. A 'parallel polish' technique was used to remove the top layer of metal.

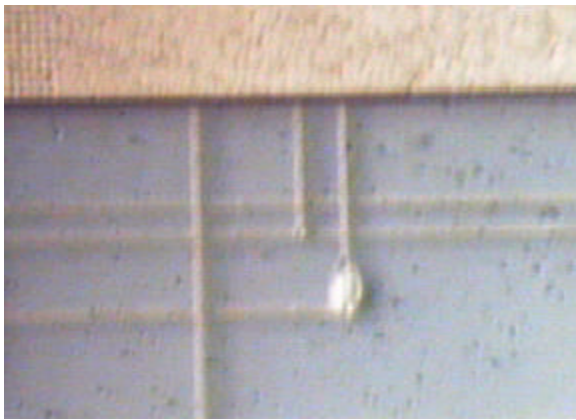
Figure 5: Detail of fused aluminum at Site B in Figure 4

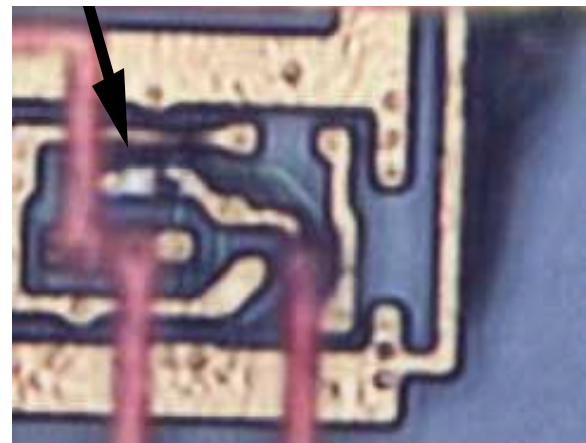
Figure 7: Example of alternate site of fused aluminum near Site C  
Note: View is of a different device than in Figure 6

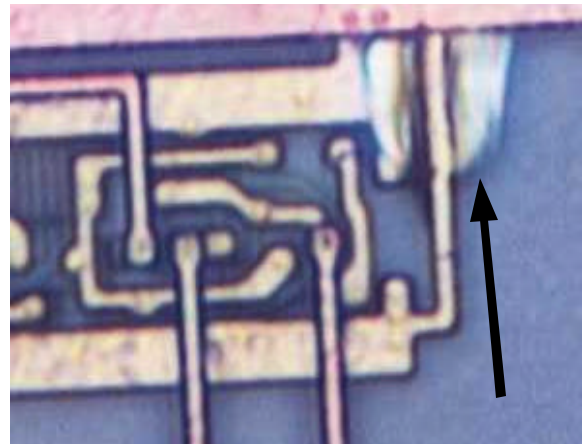
The specific location of the metal damage varied. In addition, deprocessing on sample failures revealed gate oxide ruptures in a particular PMOS transistor identified as 'P4' in the Schmitt Trigger cell, which is connected to the PWD port.

Figure 8: Another example of fused aluminum damage at Site C

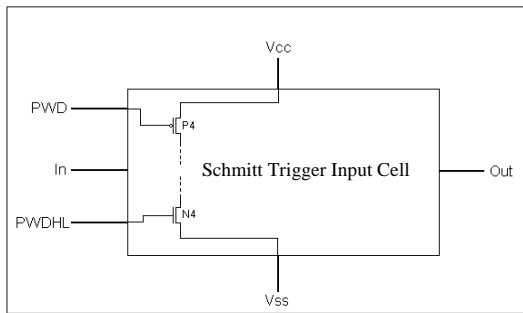
Figure 9: Schematic Diagram of the Schmitt Trigger Input Cell

0.5µm wide and approximately 6µm long; which produced the enormous area differential of 9200.

Figure 9 shows a cell-level diagram of the Schmitt Trigger circuit. Only the cell external ports are shown (PWD and PWDHL), along with two of the cell transistors. The PWD and PWDHL controls are used to enable the Schmitt Trigger operation and to set the output when disabled. In the particular application of the Schmitt Trigger cell for this pin, the PWD port was grounded (connected to Vss). Also, the PWDHL port was connected to the positive power supply (Vdd). There were a total of 44 Schmitt Trigger cells in the device that had their PWD signals connected to ground.

The repeatability of the damage site led to the belief that the failure was layout-related. Specifically, an antenna effect was suspected to have led to the damage of the gate of P4 and the fused metal interconnects. P4 was connected to the PWD port, which in turn was connected to a Vss metal bus. A careful evaluation of this connection led to the realization that this portion of the Vss bus was not connected directly to silicon until the top-layer metal was deposited.

The antenna ratio of this PWD connection was checked and found to be 9200:1. PWD was connected to Vss using second-layer metal (“M2”) which was 1700µm long and 35 µm wide. The gate oxide was
