**“The Effects of Silicon Defects on Vertical DMOS Transistors”**  
A National Semiconductor Quality White Paper

**Fayik Bundhoo** (NSSC) and **K Soundaranathan** (NSSC)  
March 2003

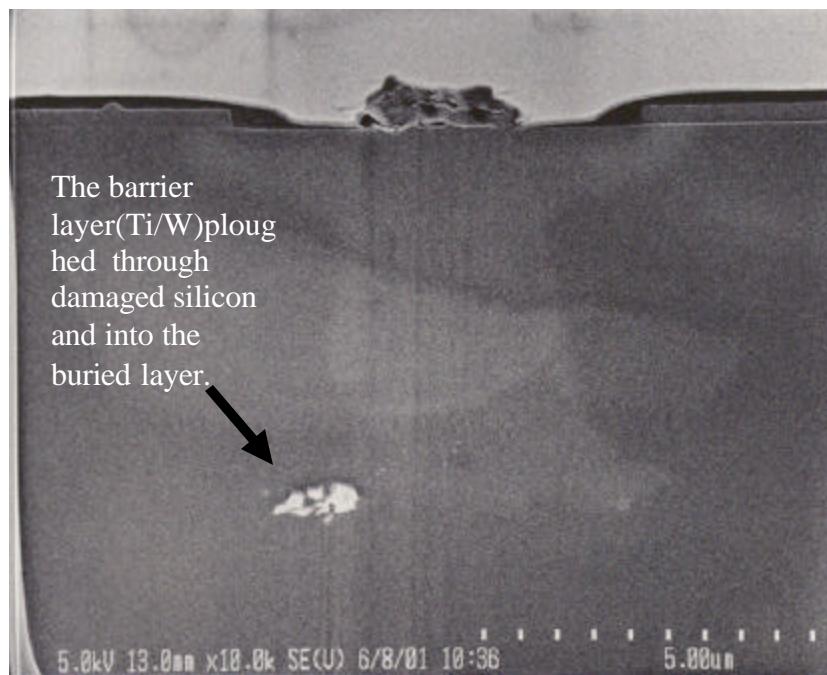
Step by step focused ion beam milling of the contact to a depth of the drain revealed presence of tungsten. EDS analysis confirmed presence of tungsten as the residual metal. The current leakage path was through damaged silicon and remnants of tungsten ploughed through the damaged silicon into the buried layer.( Figure 2)

Focused ion beam cross section across the damage silicon at the top.  
Note: presence of Ti/W barrier layer approximately 5um from top of the silicon surface

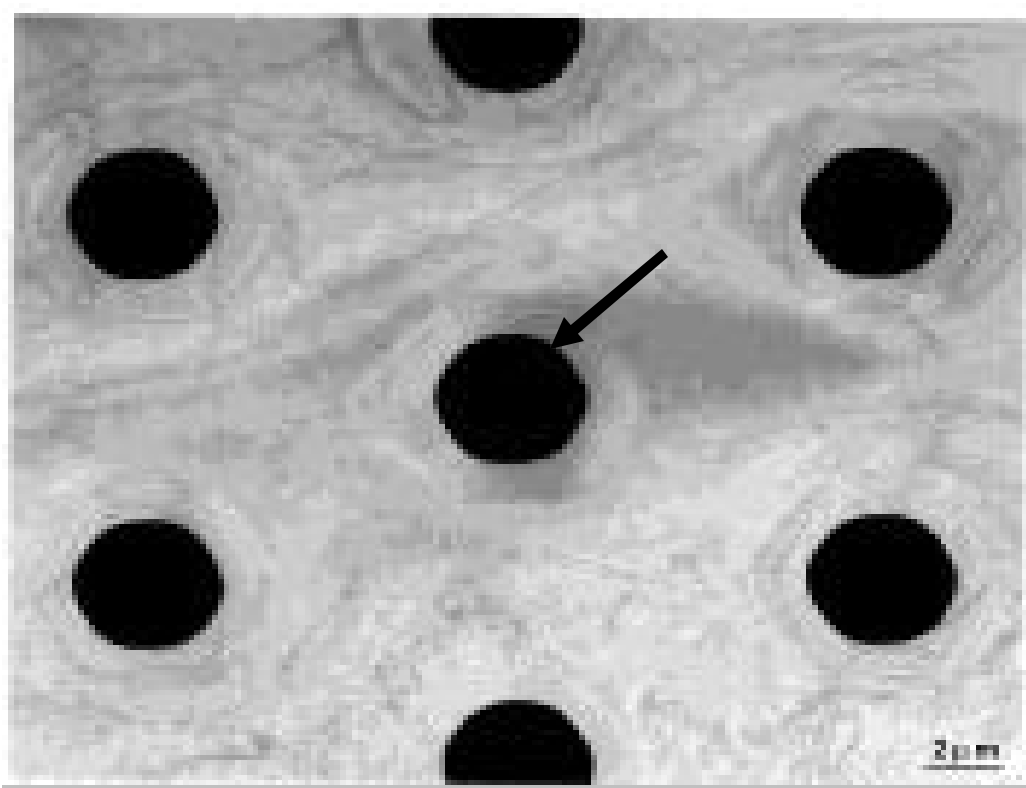
The sample preparation for TEM consisted of a cluster of 8 vertical DMOS transistors. The dark center reflects presence of composite barrier layers. The defective transistor was surrounded by good vertical DMOS transistors. A plan TEM sample was prepared. Amongst several dislocations observed, the fatal dislocation was the one that crossed the P-body/N+ boundary (Figure 1). Dislocations generally are either caused by stress at the P-body/N+ junction or caused by excessive atoms originating from N+ implantation. The authors are inclined to think that dislocation caused by excessive Arsenic implantation is the leading root cause. An optimized annealing of N+ dopants is being suggested by the authors as a viable solution. Annealing would drive excessive silicon atoms (driven away by excessive Arsenic atoms during implantation) towards the surface.

TEM analysis of cluster of DMOS array consisting of a failed transistor surrounded by good transistors (see arrow)

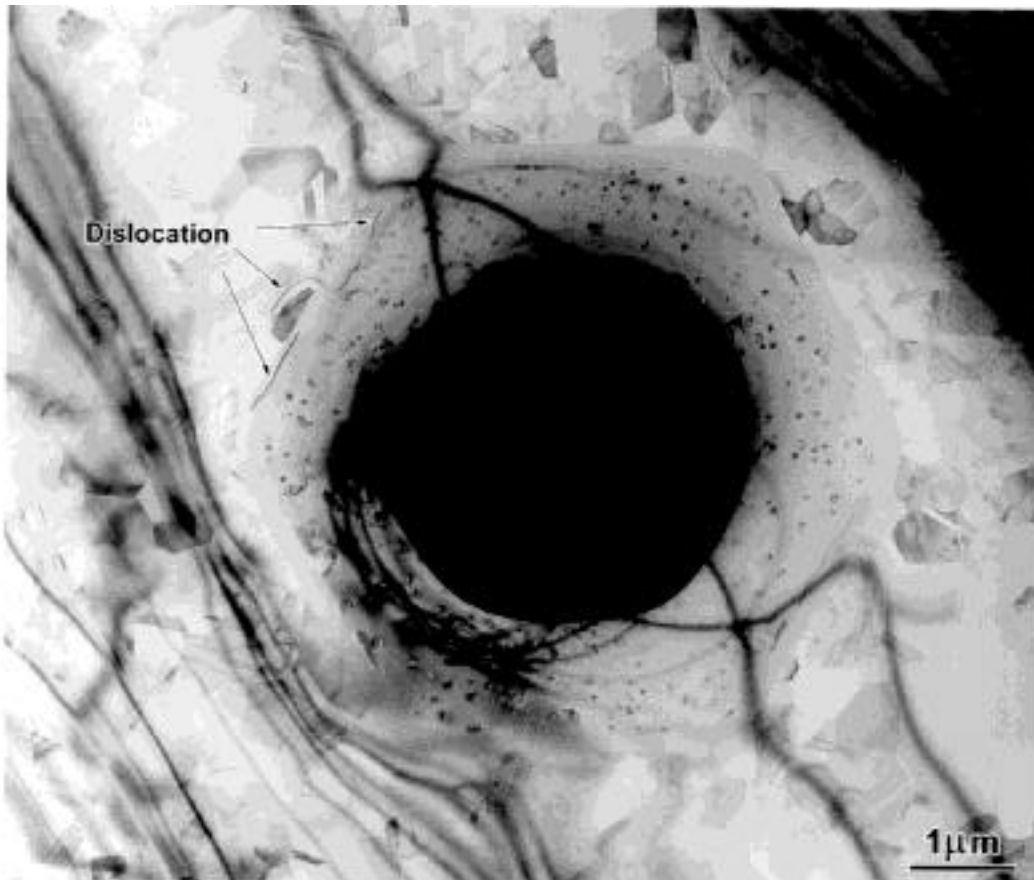
**RESULTS:** The area of concern was the annular region between the edge of gate poly and the N+ region. The failing DMOS transistor had a dislocation that crossed the P-body/N+ junction. The adjacent passing DMOS transistor did not have dislocations.

FAILED TRANSISTOR WITH DELINEATED DISLOCATION LINE CROSSING P-BODY/N+ JUNCTION
