LMX9830 Bluetooth Serial Port Module - Firmware Release Notes

National Semiconductor
Firmware Release Notes
January 2007
Revision 1.3

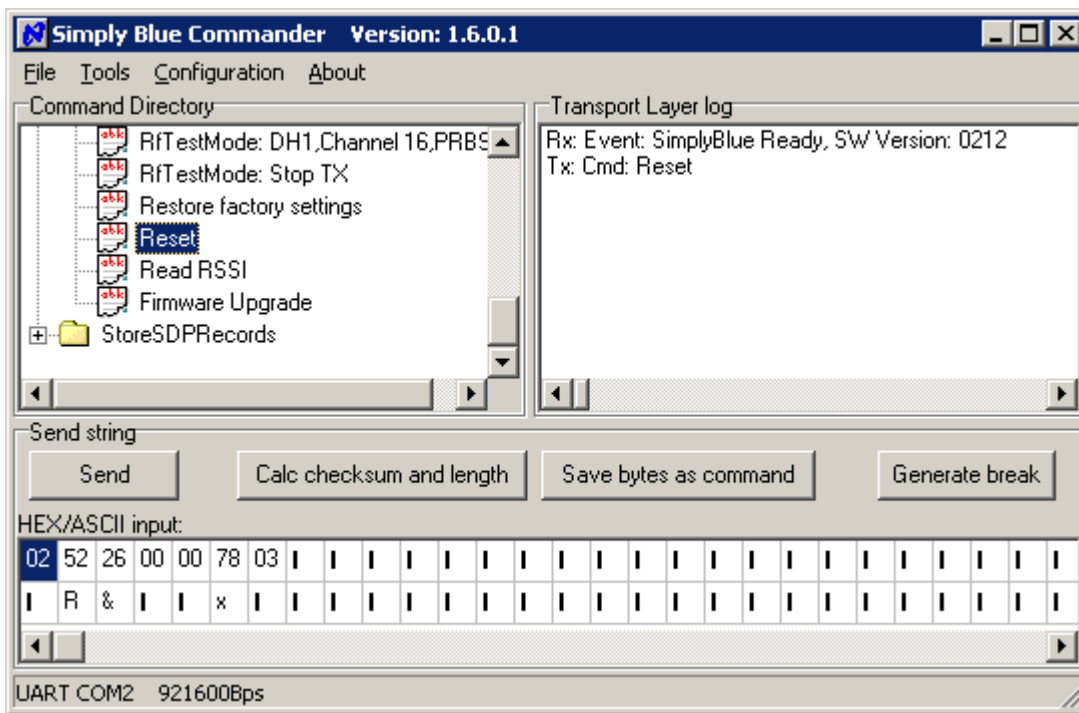
Figure 1-1. “SimplyBlue Ready” in Simply Blue Commander

See Figure 1-1 for a screenshot of the event in Simply Blue Commander.

on which the bold bytes indicate the firmware version (in this case 0212).

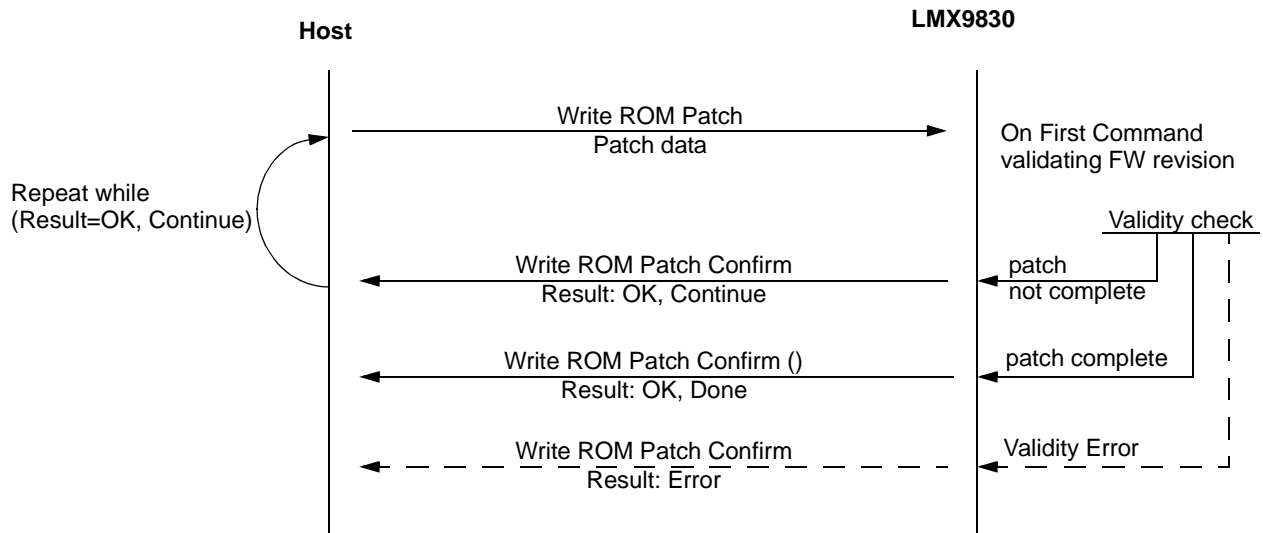
Figure 1-2. Write ROM patch flow

In case no EEPROM is connected, patches need to be supplied via the command interface using the “Write ROM patch” command. Since patches usually require more than one command, the patching requires a specific command flow to be

followed. See Figure 1-2 for the general patch flow. The complete process is also described in the “LMX9830 Software Users Guide”.

The Write ROM patch mechanism includes a validity check of the ROM pushed to the device. In case, no error is found the error code is either 0x01 for continue or 0x00 for OK, Done.
